**RTS-M DEVENS
DEVENS , MA
MAJ CLONCH
SGM HAYNES**

RTS-M Devens Storyboard

Entry in the PS Magazine, patch on the oil drain line on the new multi-temperature refrigerated container systems (MTRCS)

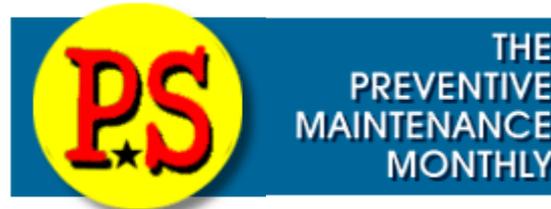
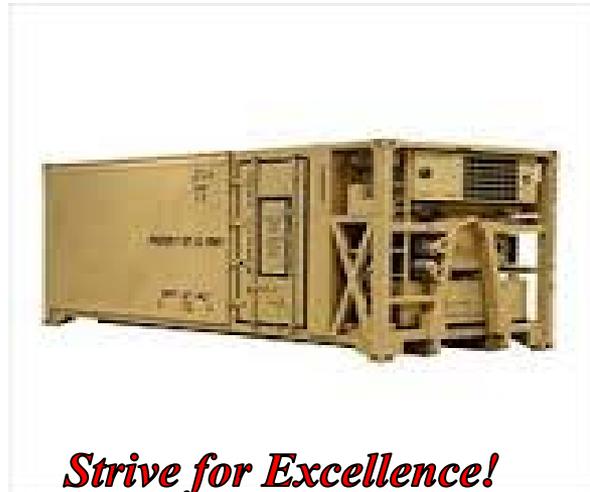
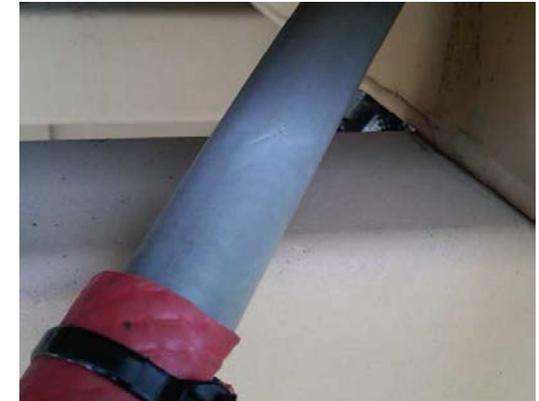
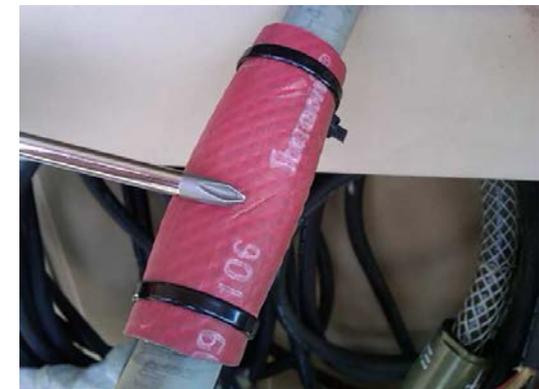
The 91C's found the problem on each of the systems. The engine oil drain line is connected to the diesel engine's sump on one end and an oil drain valve on the other. The problem comes where the oil drain line passes through the MTRCS frame between the sump and valve. The tolerance there is very tight, so vibration during movement, transportation and operation allows the drain line to rub against the frame.

The front part of the frame is rounded and causes no problem. But the inside of the frame is another story. That edge is sharp and jagged and the drain lines on both of the new MTRCSs showed signs of wear. If this hose is cut, the entire contents of the oil sump will drain and the engine could burn out.

As a temporary fix, we wrapped the drain line with a piece of reinforced radiator hose and held it in place with wire ties, NSN 5975-00-984-6582. Then we periodically check the drain line to make sure the radiator hose is still in good shape.
